GENERAL MOTORS
DCS6941
URGENT - DISTRIBUTE IMMEDIATELY

Subject: N242442100 - Customer Satisfaction Program
Inoperative Trailer Brake Function

Models: 2022 Chevrolet Silverado 1500
2022 GMC Sierra 1500
Equipped with BRK APL CTRL FEATURE-INTEGRATED TRAILER
BRAKE (RPO JL1)

N242442100 Inoperative Trailer Brake Function

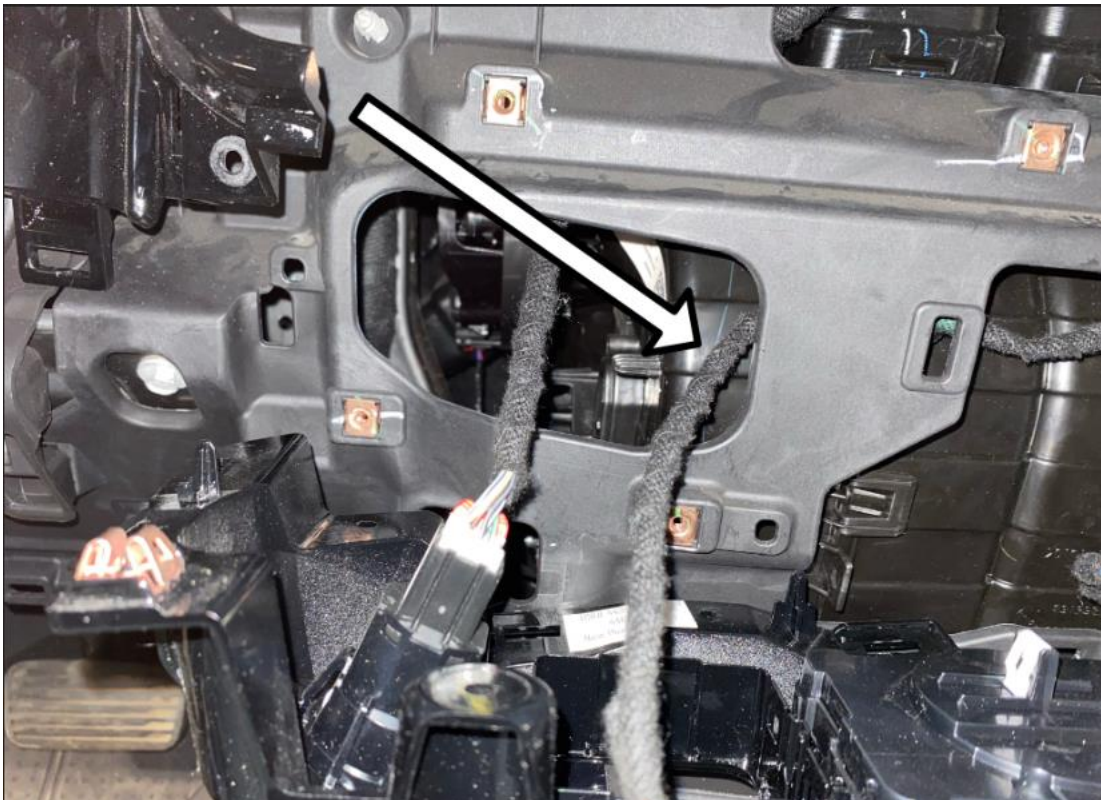
6666137

Note: The wire connector for the Trailer Brake Switch will be behind the Instrument Panel Accessory Bezel.

3. Locate and gain access to the Trailer Brake Control Switch Wire connector, found in the dashboard, behind the Instrument Panel Accessory Bezel.

Note: If the Trailer Brake Control Switch is not initially installed on the vehicle, install a new Trailer Brake Control Switch into the Instrument Panel Accessory Bezel with the provision for the switch. The On/Off Vehicle Switch will also have to be relocated on the new Instrument Panel Accessory Bezel.
